Subsidence above abandoned underground coal mines, Deep Run Mining District, Henrico County, Virginia.

Stanley L. Hite, P.E.

Todd A. Beach

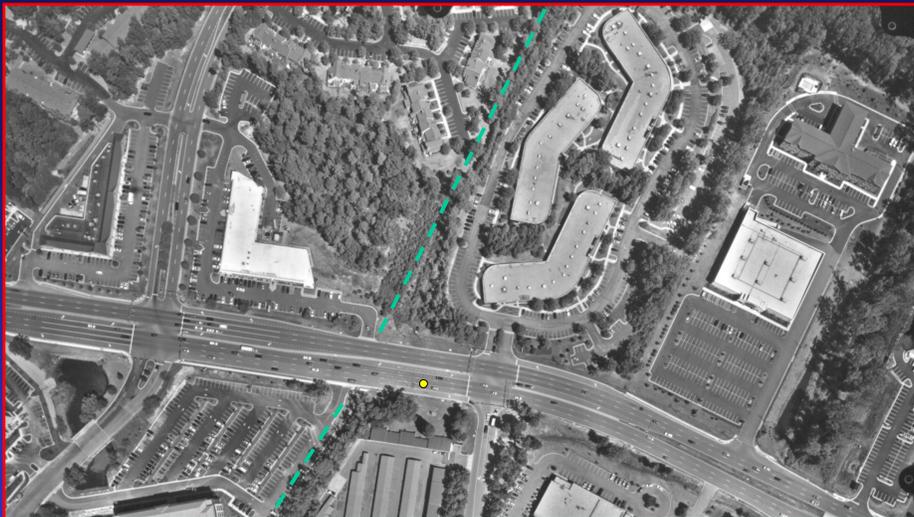
Air photo of site. Yellow dot marks site of 1998 failure. Green dashed line marks location of abandoned coal railroad track bed.

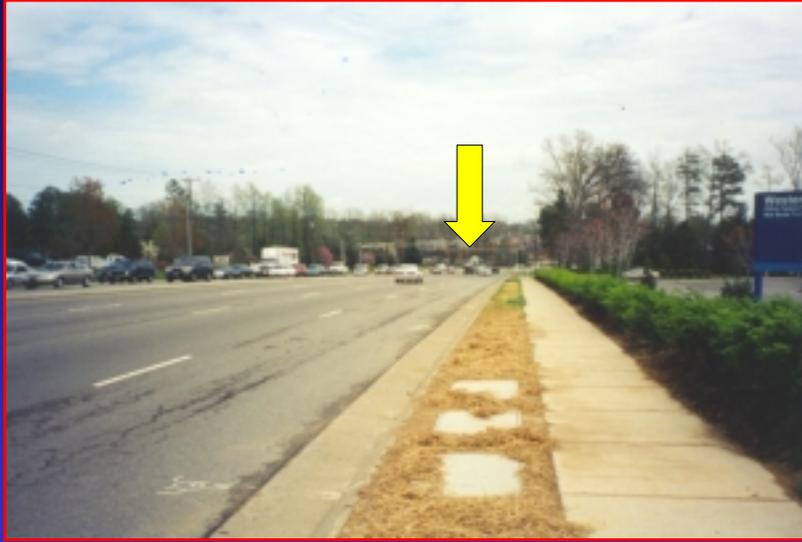
Looking East into the Deep Run Triassic Basin along U.S. Route 250, West Broad Street. Yellow arrow marks approximate failure location.

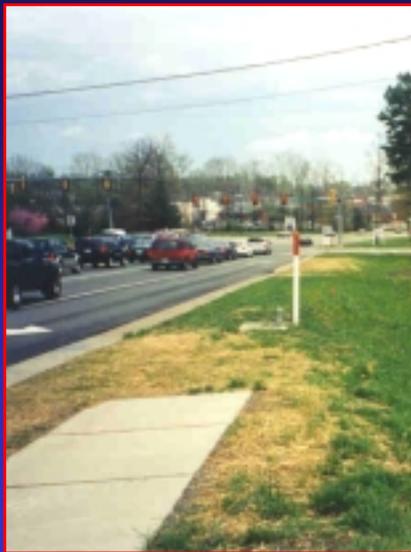
Original failure was in travel lane adjacent to depressed area of curb and gutter, approximately where the red SUV is parked. This area contains abundant underground fiber optic, natural gas, water, sewer, telephone, and electric services.

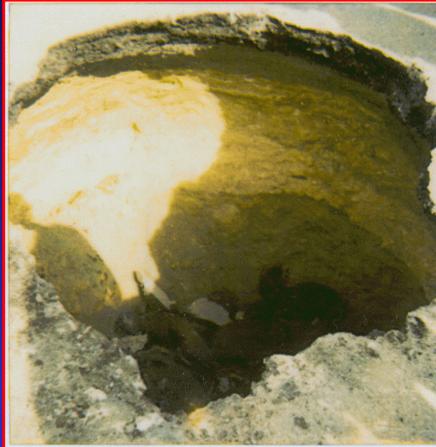
250 E.B AT DEEP ROCK
COLLAPSED MINE SHAFT
12' LX 8' WX 30' deep

Polaroid photo of shaft
exposed upon removal of
the overlying asphalt
pavement.

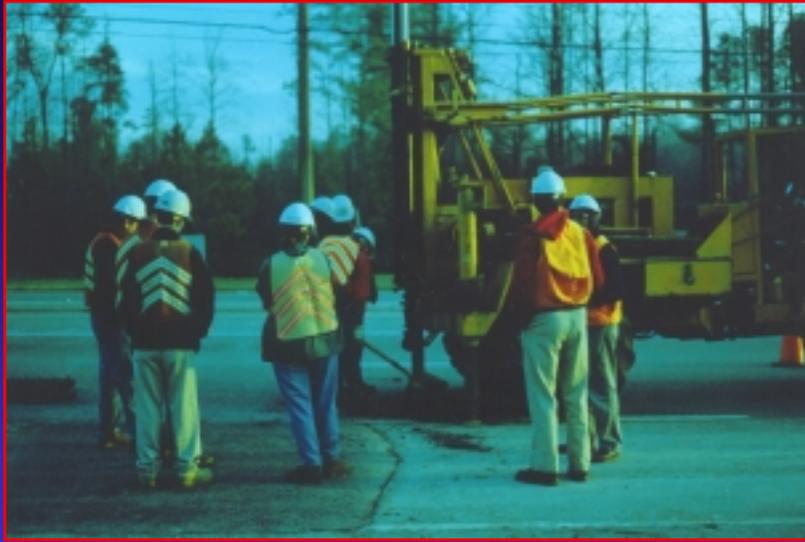
The morning after the initial collapse and repair. Note choice of positions, engineers and administrators above repaired shaft, geologists and drillers safely off to one side.

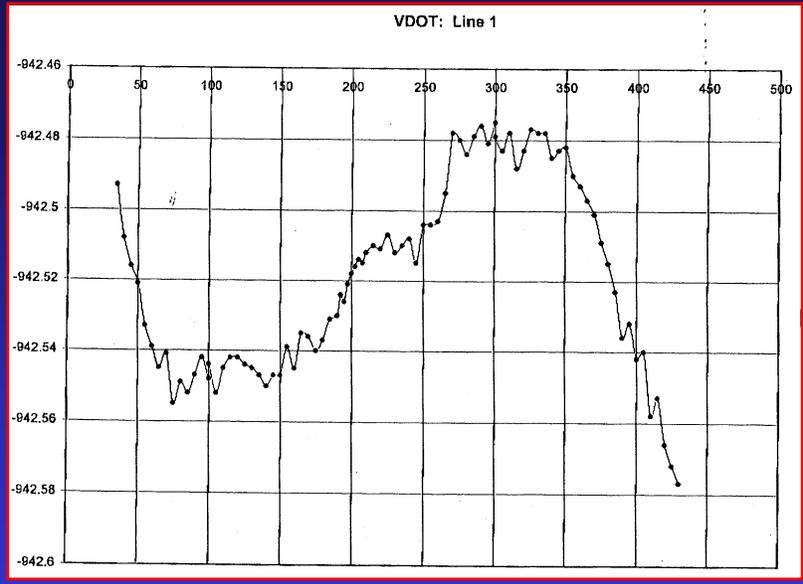
Printout of actual microgravity measurements.
Individual low points were drilled to verify presence of voids without success.

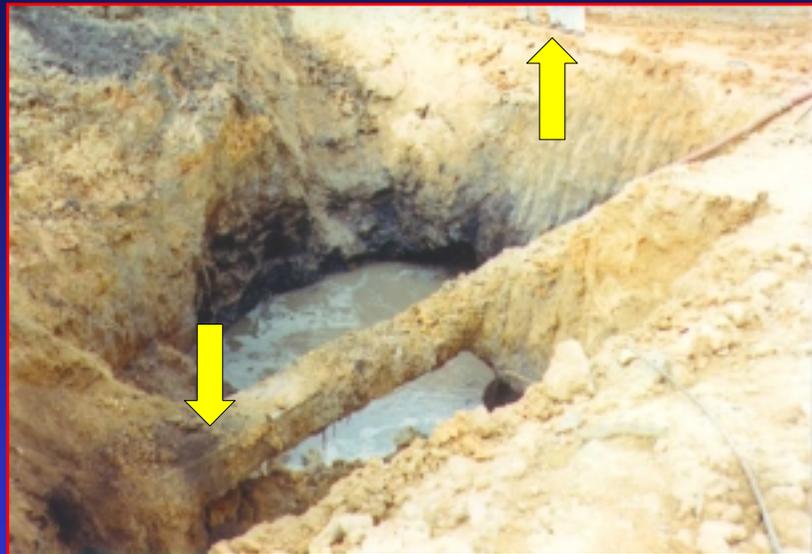
Mine workings encountered during original construction before dewatering. Note large support beam and feet at top of photo for scale.

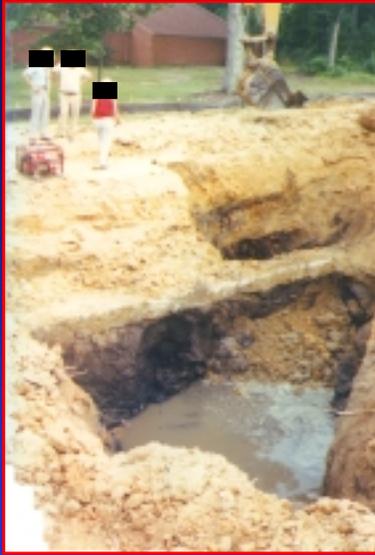
Mine workings excavated during original construction before attempted dewatering. The aggregate backfill placed during construction was not encountered during our investigation.

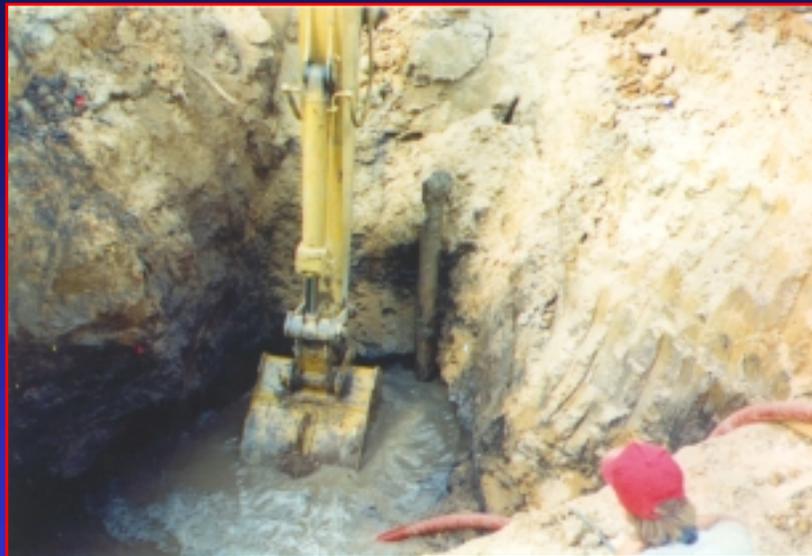
Attempted dewatering of the mine in progress. Total track hoe boom length is approximately 20 feet.

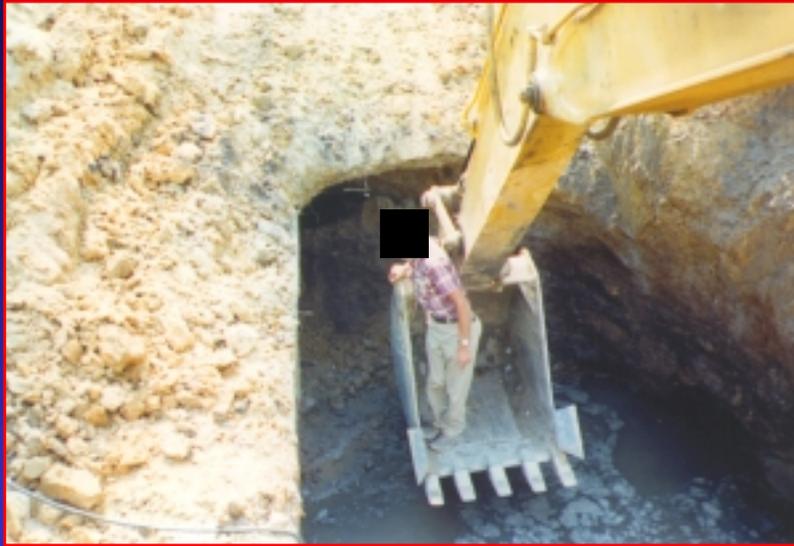
Mine workings after partial dewatering. Complete dewatering was not achieved due to rapid refill rate.

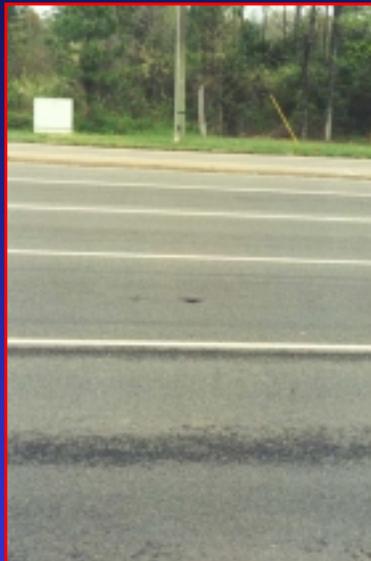
Slight dimples in the Superpave asphalt overlay due to subsidence above the grout pipes that were left in place after installation of the grout bags.

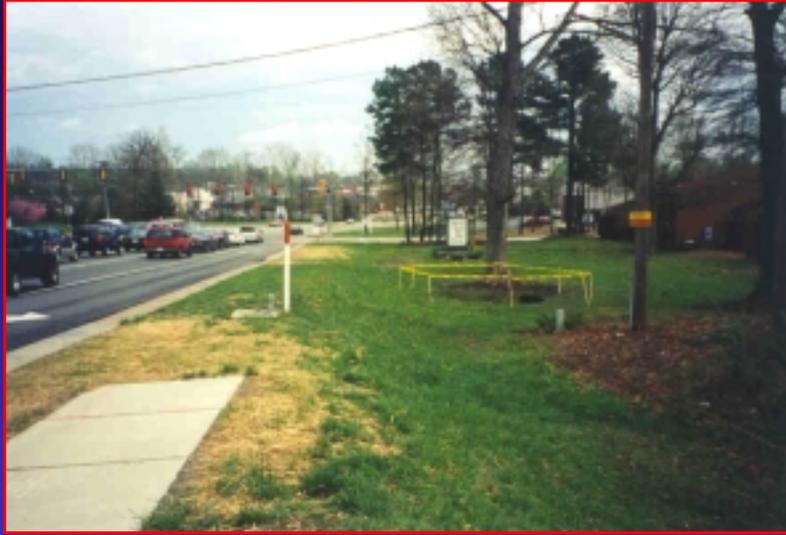
This shaft opened up in the fall of 2000. It is just beyond our Right of way outside the area repaired.

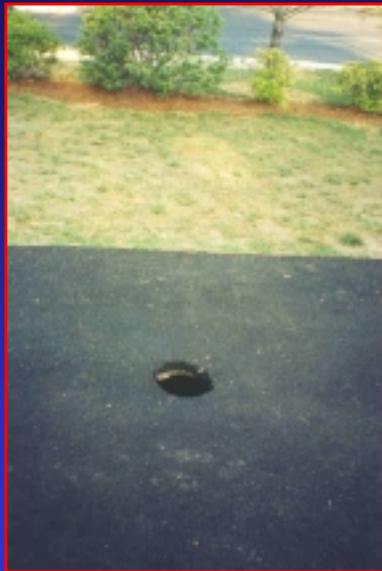
This “small” shaft opened up in a private driveway just beyond our Right of Way on a nearby road.

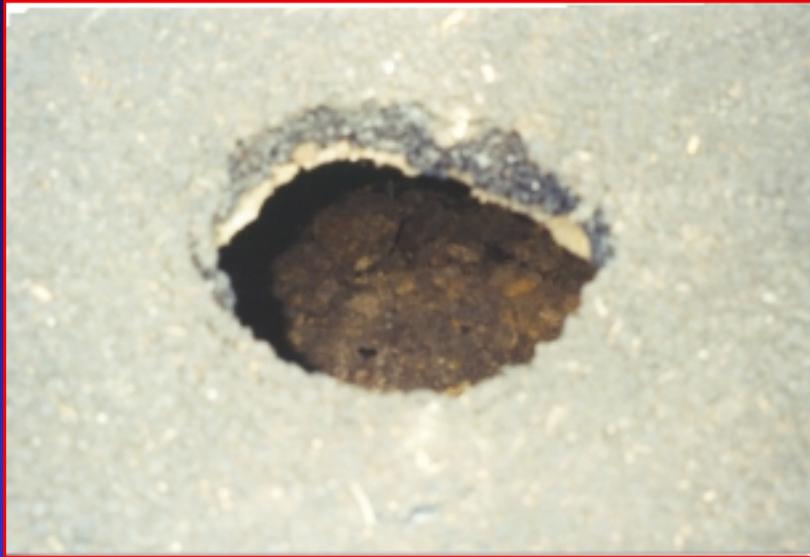
Down hole close up.

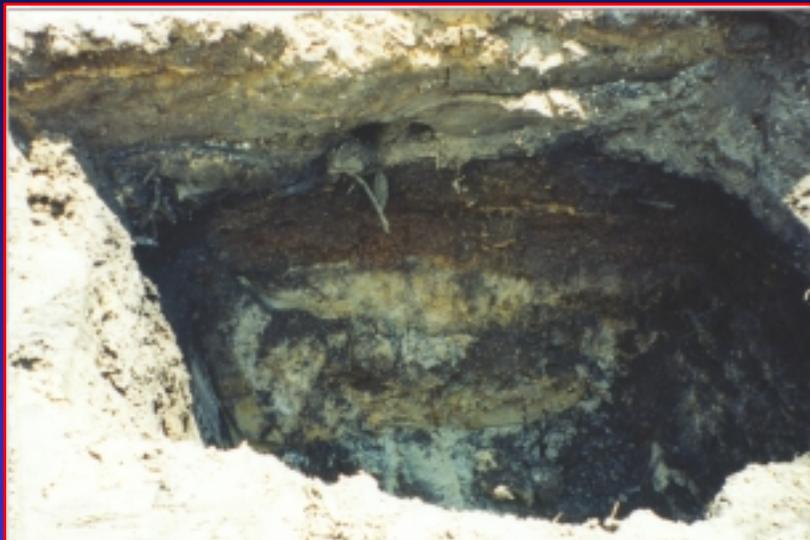
Shaft was originally backfilled with organic debris, settled approximately 5 feet in depth only 8 feet from garage door.
